# BASTIÓN DE SAN DIEGO

INTRAMUROS ADMINISTRATION  
MINISTRY OF HUMAN SETTLEMENTS

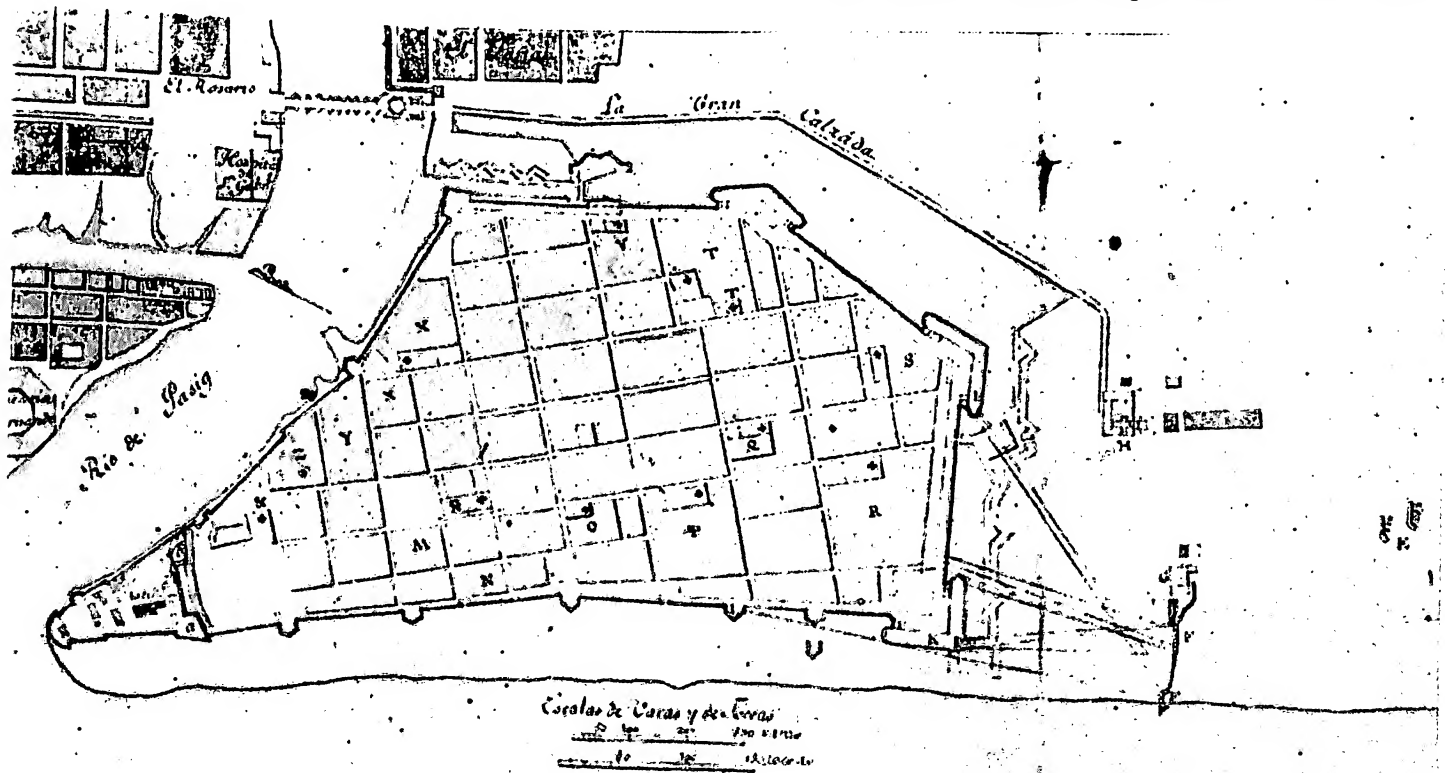
Figure 6. Plan submitted by Tomás de Castro y Andrade showing the status of the wall during the British Occupation, indicating sections affected by British bombardment. Presumably submitted after the British Occupation.

The plan by Tomás de Castro y Andrade (Figure 6) indicates the areas affected by the bombardment. It only emphasizes the structure of the bulwark itself, showing it simply terraced with no indication of the old tower. This is also the case in the maps of Muñoz and of Buzeta and Bravo. The final stages in the rehabilitation and completion of Bastión de San Diego are limited within the years 1767 and 1785, as borne out by the maps drawn during this period. These are maps drafted by military engineers, who would take charge of repairing the walls: Feliciano Márquez, 1767; Dionisio O'Kelly, 1770 and 1771; Thomas Sanz, 1778, April and November 1779, 1784 and 1785.

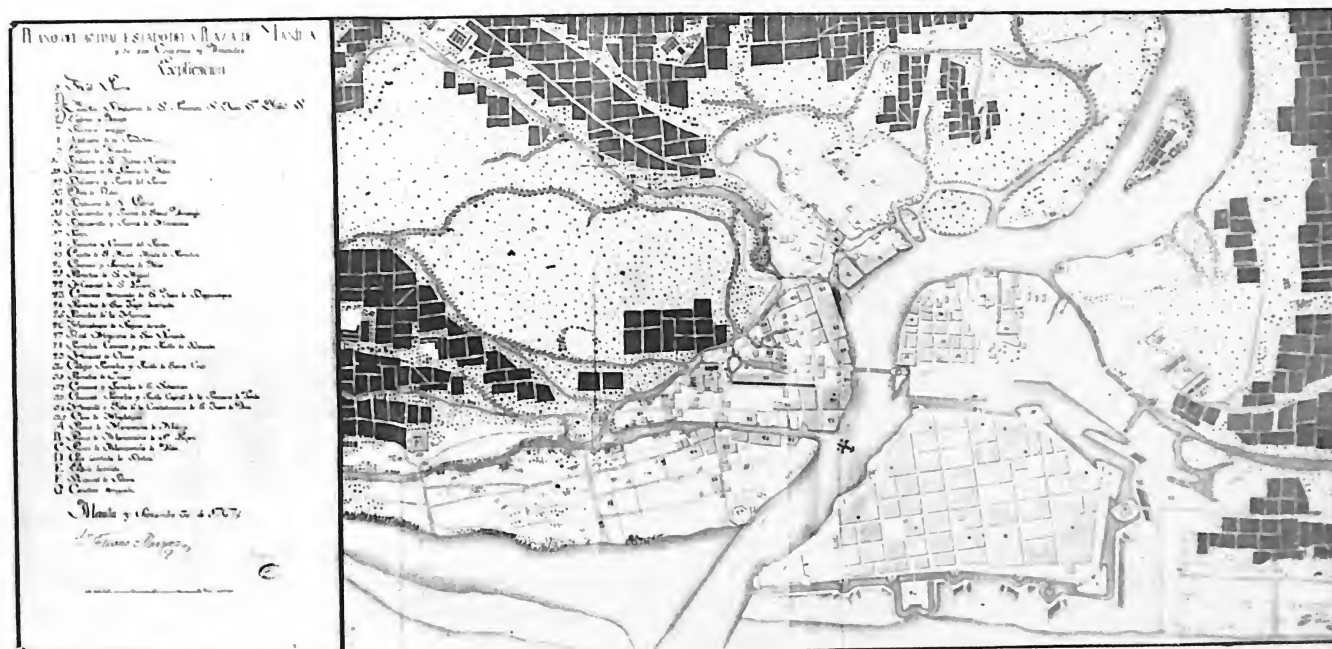
Figure 7. Plan submitted by Feliciano Márquez dated 1767 showing the state of the fortification after the British invasion.

The map of 1767 (Figure 7) signed by Márquez is important to this study because it records no change in the bastion since the immediate post-British period. The maps submitted by O'Kelly (Figures 8 and 35) show the circular ruins of the old tower marked "F" in the first plan. Another structure, marked "D," indicates the location of a vault declared useless for being tomblike and airless. It also includes two other structures, which also appear in the plan of 1731 of Tomás de Castro y Andrade. Labelled *plazas baxas*, they would approximate the interior courtyards of the Bastión de San Andrés. The latter, however, though submerged below the terreplein, is elevated from the present street level. San Diego's low courtyard located on the southwest, parallel to its flank, is on the same level as the present street. Archaeological excavation confirms the existence of one such *plaza baxa*; that supposed to exist on the east side has not been verified, as this part has caved in. The existence of the old tower's ruins is confirmed in the maps submitted by O'Kelly and Sanz (Figures 8 and 11). Nowhere in the succeeding maps of the walled fortification would appear the cistern excavated in the archaeological exploration, represented by the inner circular structures. A microfilmed document on the fortification at the Ateneo de Manila Library gives a clue to what may have happened.

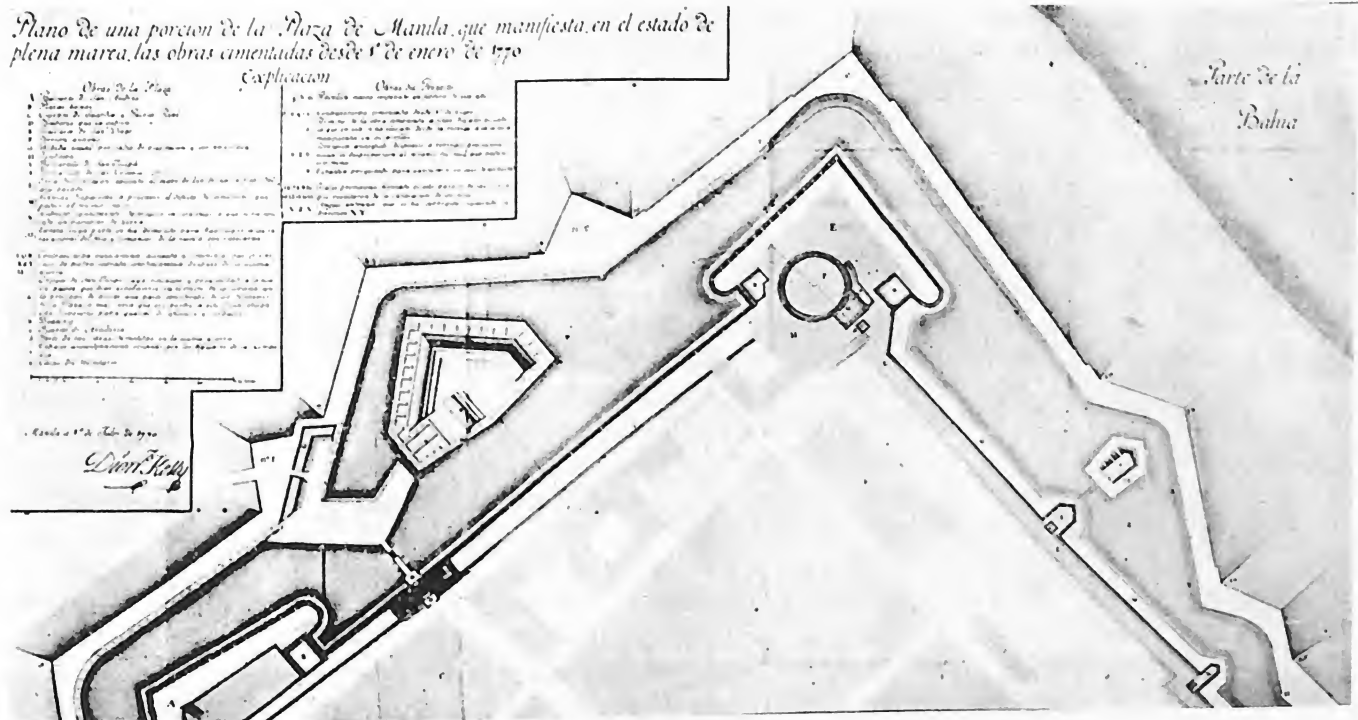
Figure 8. Plan submitted by Dionisio O'Kelly showing important features of Bastión de San Diego, acknowledging the existence of two subterranean courtyards described as "tomblike and airless."

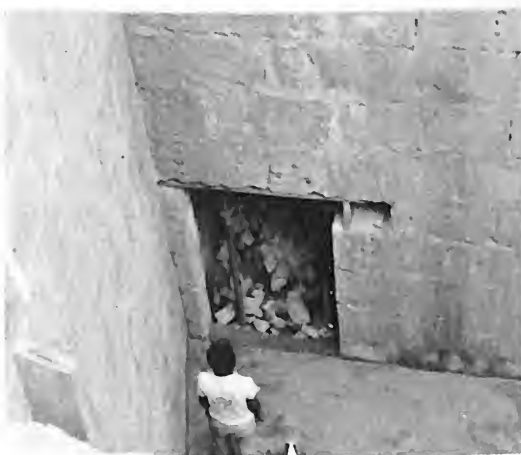
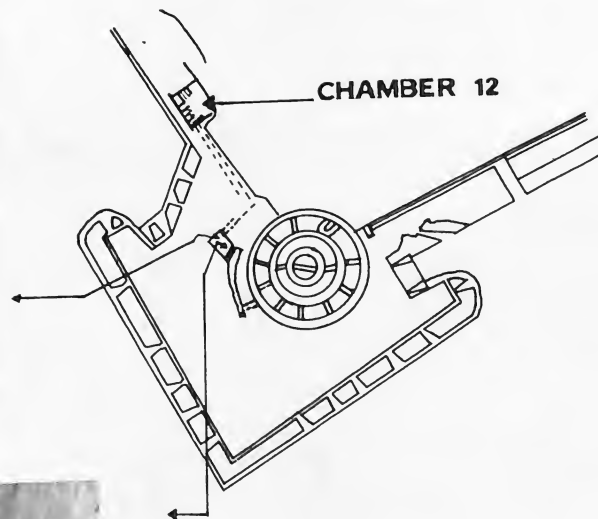
Figure 9. One of the submerged courtyards that coincide more or less with the bóveda illustrated in the O'Kelly plan of 1770. It faces to the north and probably connects through an underground tunnel to the exitway along the curtain wall toward Bastión de San José.

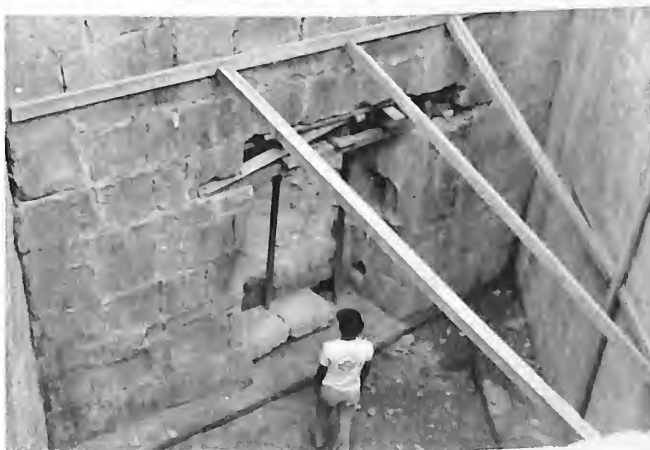
Figure 10. This opening is located on the wall contiguous to that shown in the previous picture. It is oriented to the south and is connected to a narrow passageway with an archway at the end.

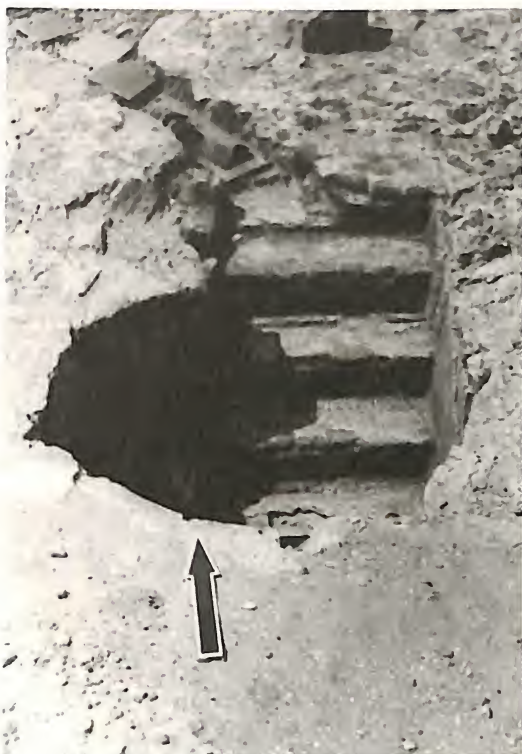
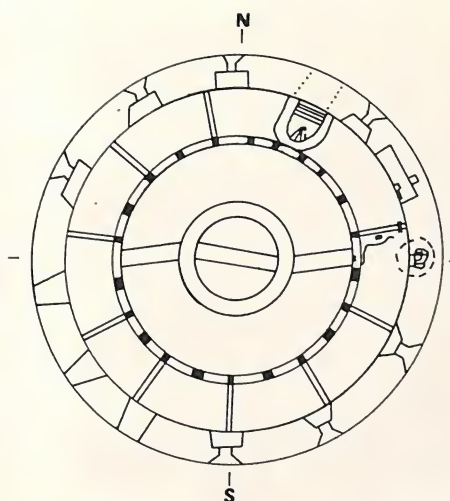
Figure 16. Top view of the stairwell built within the wall of the third circular structure.

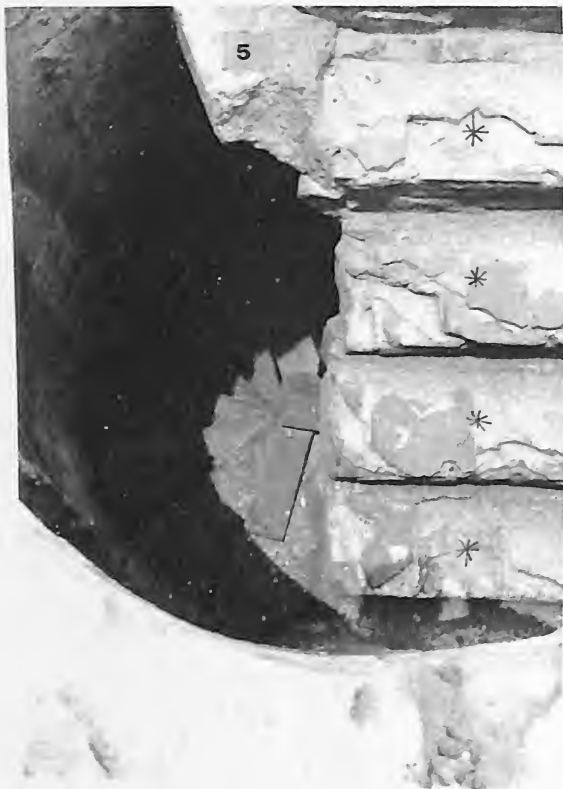
Figure 19. This straight stair was added to the structure at a much later period (see reconstructed documentation of the spiral staircase early and later period, below). It led to a ledge and a low opening that leads to the staircase by the manhole.

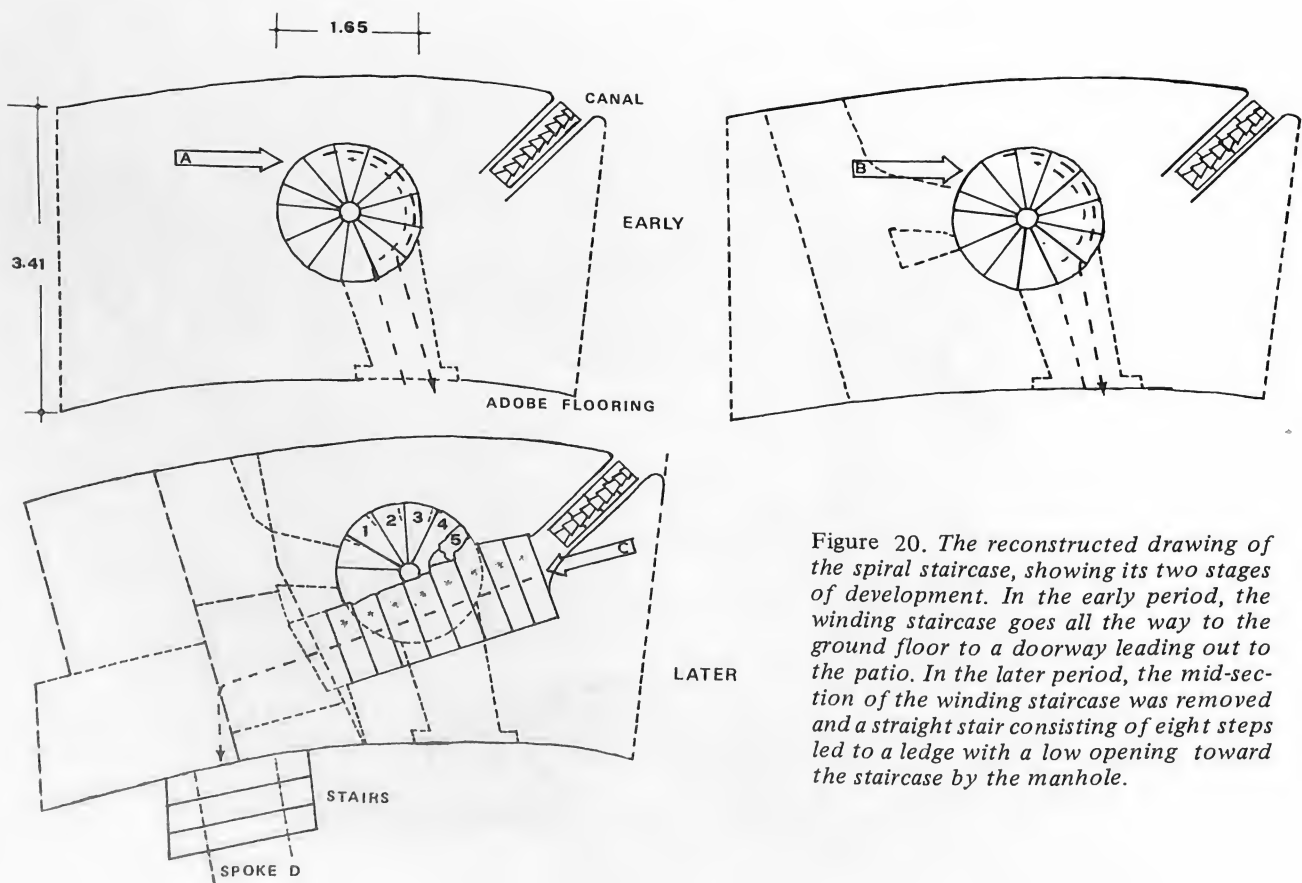
Figure 20. The reconstructed drawing of the spiral staircase, showing its two stages of development. In the early period, the winding staircase goes all the way to the ground floor to a doorway leading out to the patio. In the later period, the mid-section of the winding staircase was removed and a straight stair consisting of eight steps led to a ledge with a low opening toward the staircase by the manhole.

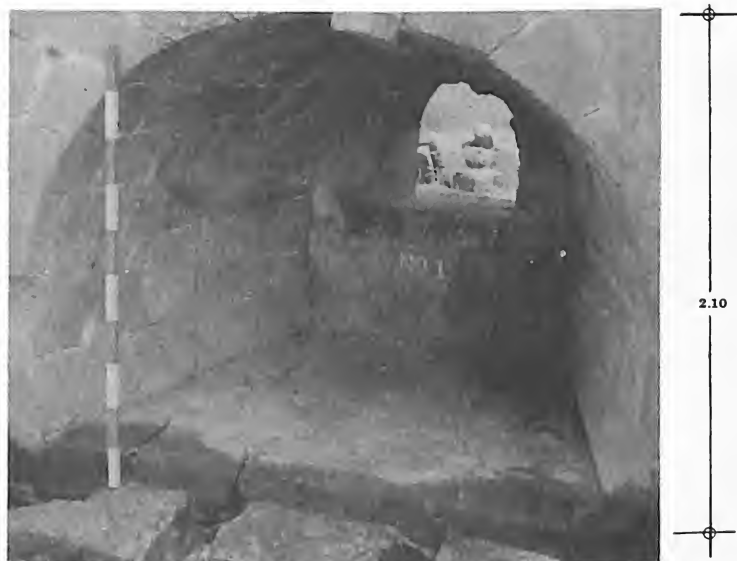
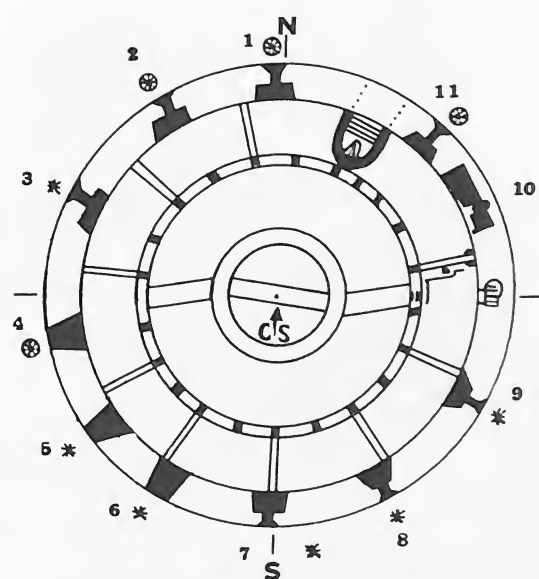
Figure 21. Casemate No. 1 falls within the north quadrant. It is the only casemate that still looks out to the open field, unobstructed by the confining wall of the bulwark.

Figure 22. C/S : Center station: S 87".  
5E Depth 3.65 m.  
Distance 26.50 from D.P.

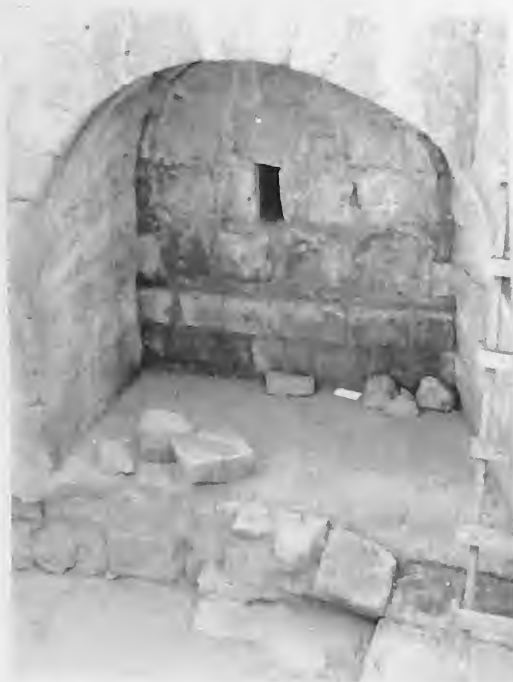
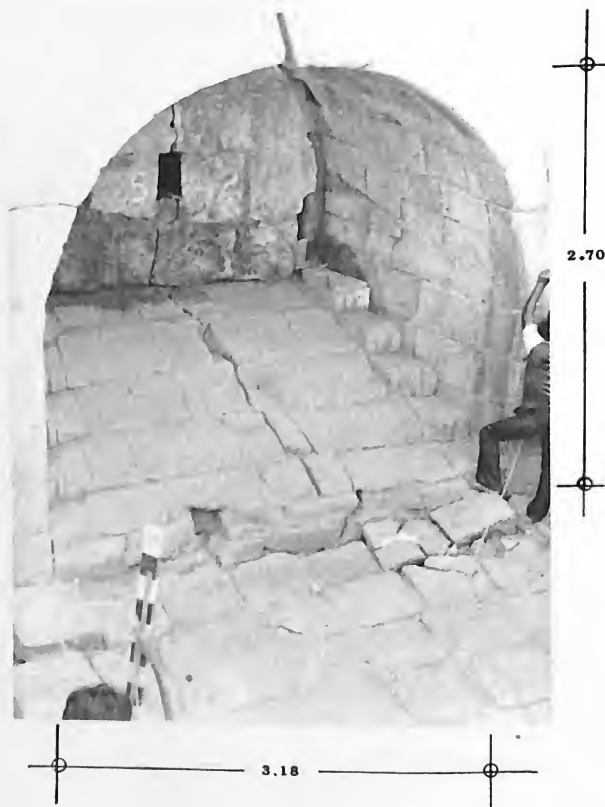
Figures 25, 26, 27. Casemates Nos. 4, 5 and 6, all located on the southwest quadrant, are simply arched chambers. All have the narrow apertures mentioned in Román's description of the old tower. They have taller arches but narrower width.

Casemate No. 5 has a gradually sloping floor, which could have been used for pushing the cannon up the ramp. It appears to have all the features of the older construction, even the paving outside its chamber.

Casemate No. 6 appears in a "disturbed condition." Its opening has been partly sealed by adobe blocks from flooring till midway of the arch. Soil fills its inner cavity, in an attempt, perhaps, to raise the flooring. On the other hand, the flooring of casemate No. 4 follows the style or manner of the newer casemates.

It is to be observed that chambers four, five and six (Figures 25-27), located within the southwest quadrant, appear to be of cruder construction, whereas the remaining chambers look better finished and have wider openings oriented outwards (Figures 21, 23-24, 28-32). Again, the aforementioned chambers have narrow apertures that recall Román's complaint: mere loopholes through which the artillery protruded. Beyond noting these differences and impressions, one has also to admit that there are no further corroborative data which could establish the age of the chambers.

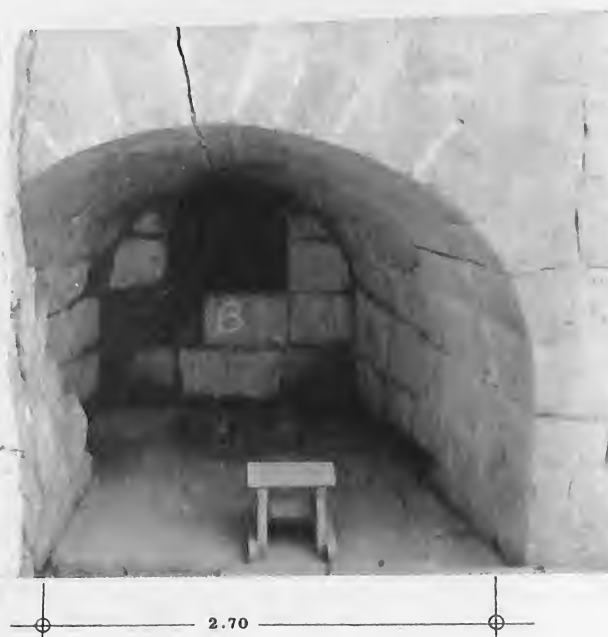
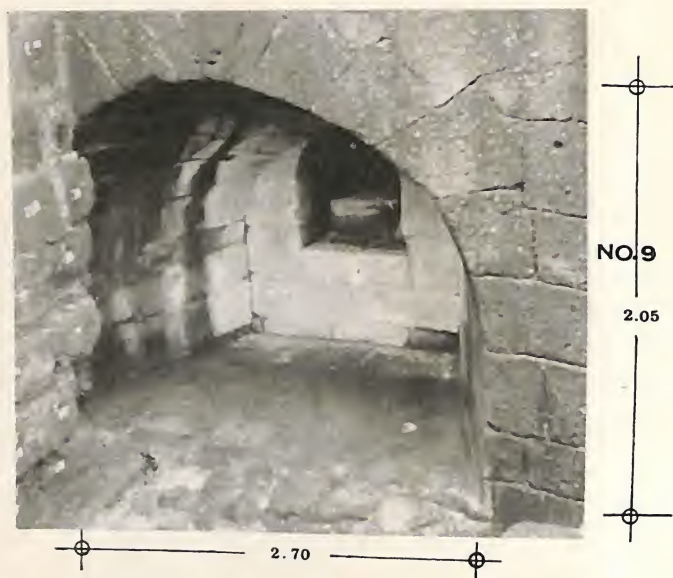
Figure 29. Casemate No. 8 manifests the same deep cleavage that has marred its otherwise perfect condition. The wall of one of the spokes partly encroaches on its opening.

Figure 30. Casemate No. 9.

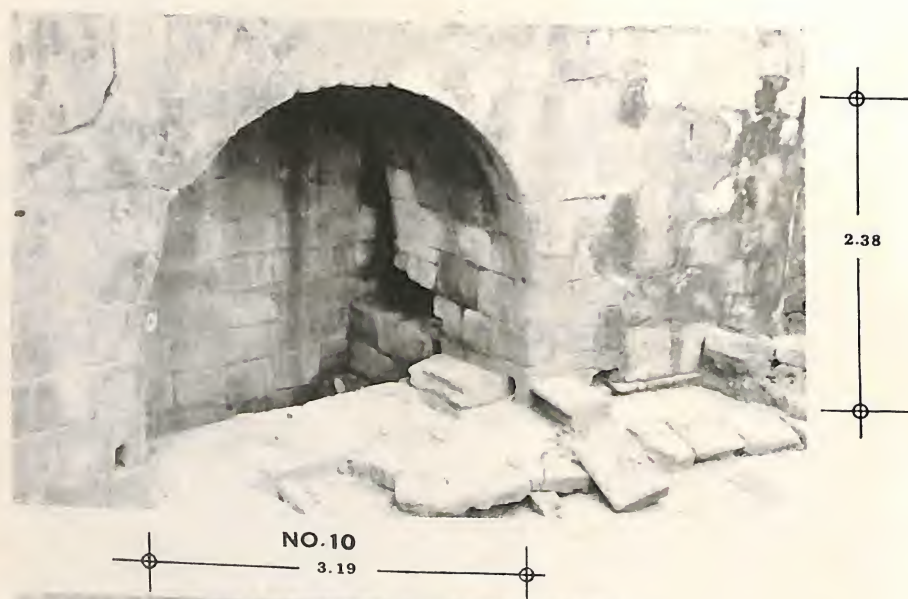
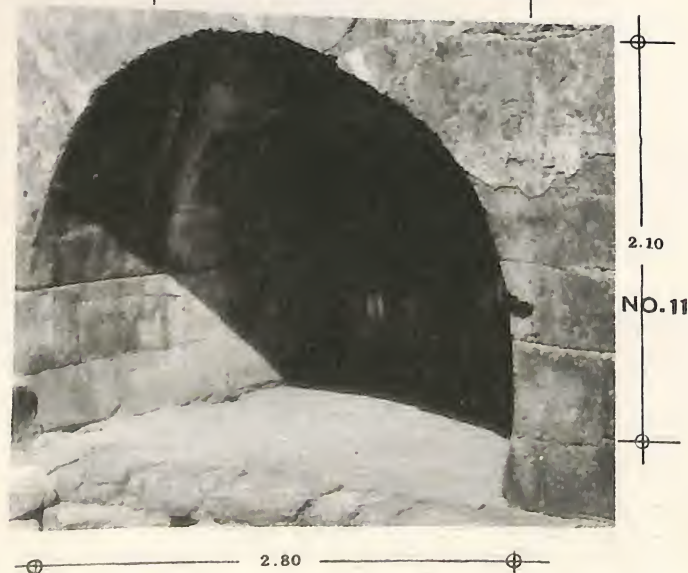
Figure 31. Casemate No. 10, which appears to belong to the same period as 4, 5 and 6, has a split-level flooring. The outer chamber is on the same level as the ground floor but its inner chamber has a deep trough several meters deep. Its arch is also semi-detached from the wall, revealing a tiny archway leading upward toward the spiral staircase. The entrance of the outer chamber has deep grooves which might have held some kind of door.

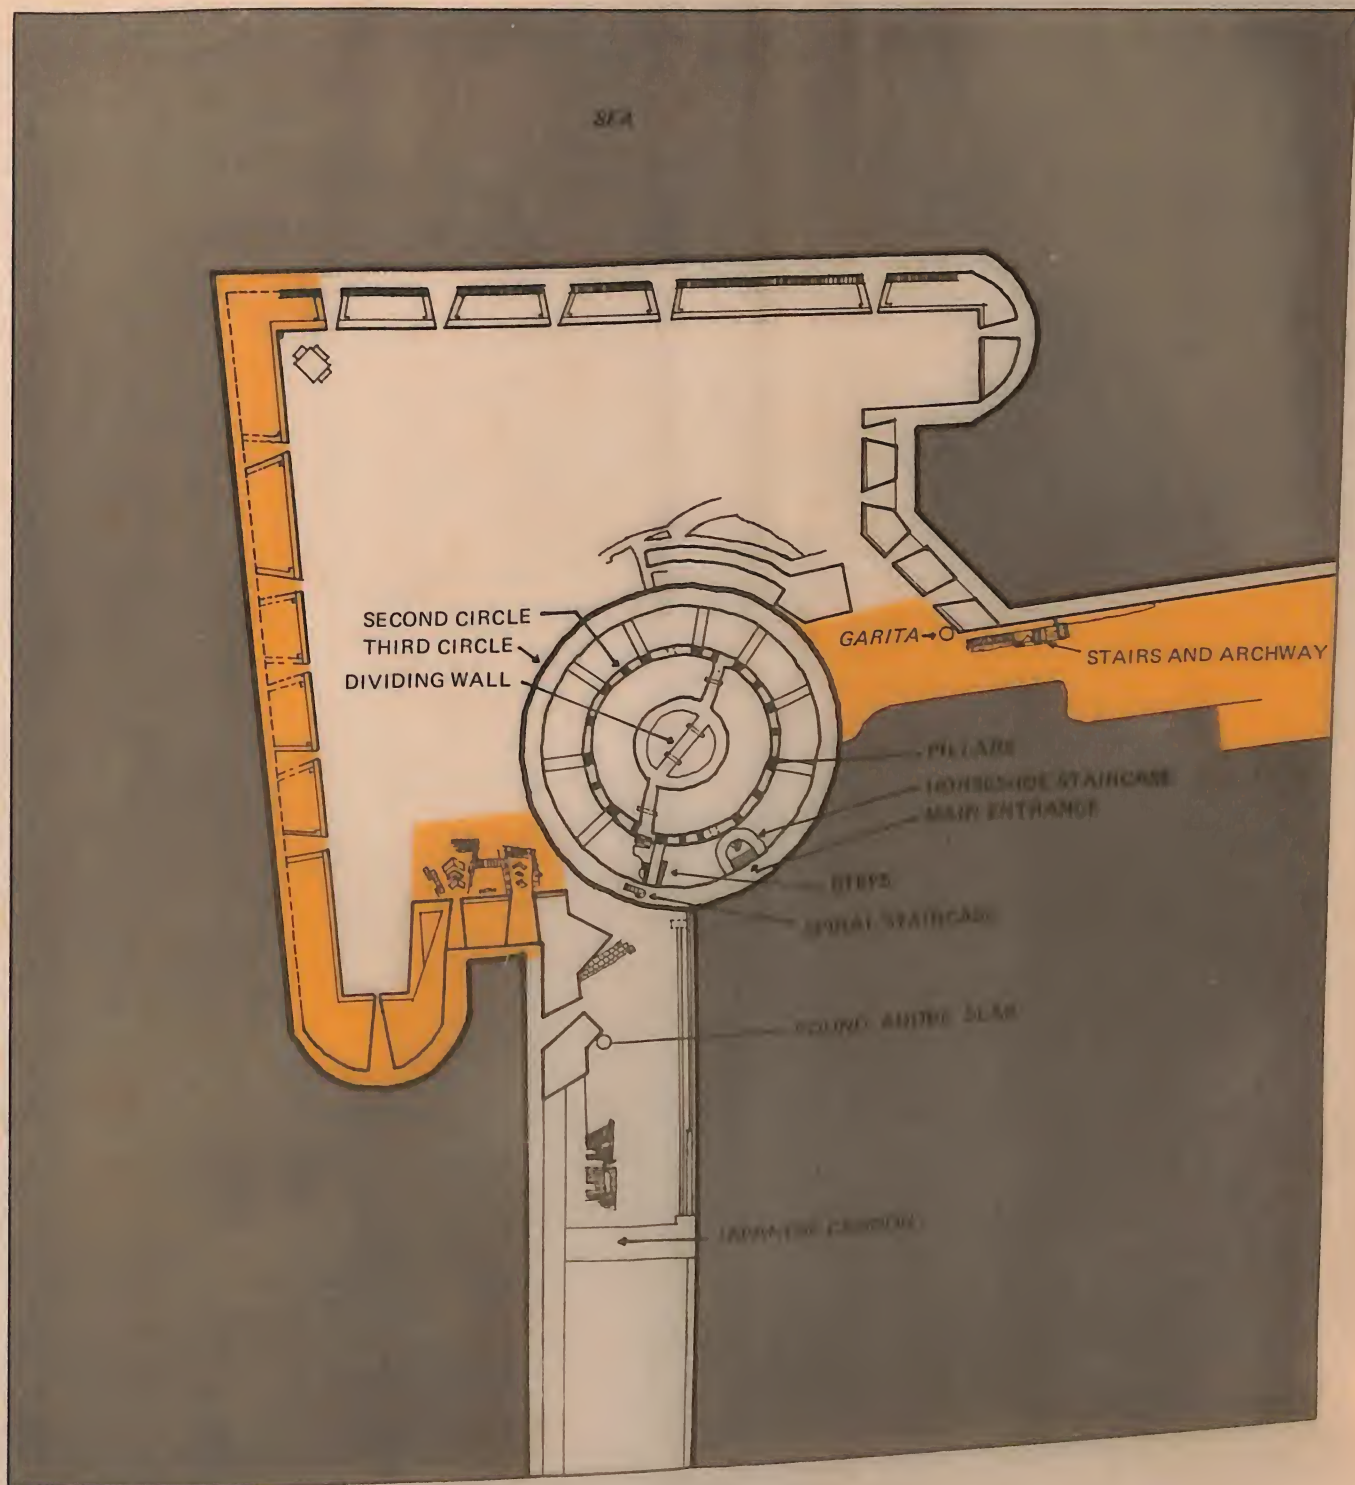
Figure 33. Bastión de San Diego shown at the end of the excavation in 1982. Besides the parapet and the lone garita on the north flank, various other structures appeared as the soil fill was removed: gun emplacements on the east orillon, stairs facing the tip of the bulwark and the three circular structures. Below the terreplein appeared the horseshoe staircase, the spiral staircase, the three sets of stairs sandwiched between the ground of the third and second circle, east quadrant; the subterranean courtyard to the west and the archway and stairs by the curtain wall on the north corner.

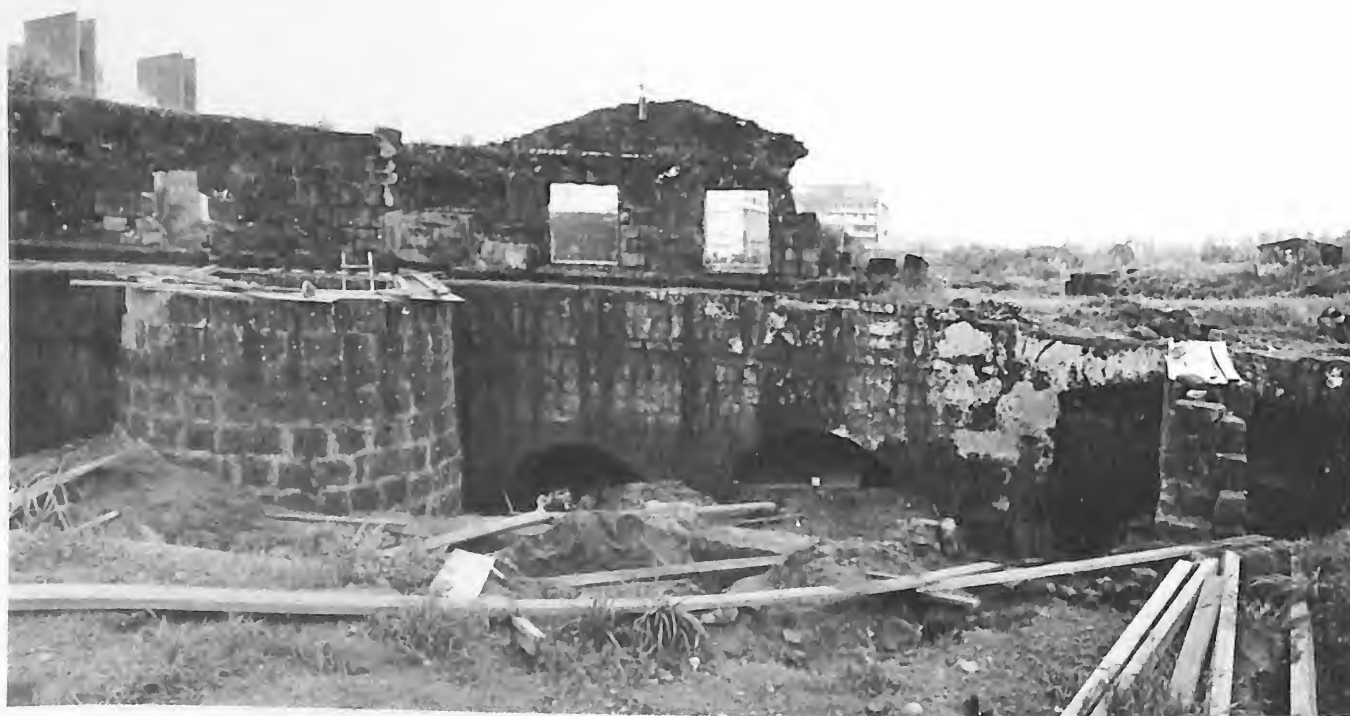
Figure 43. *The interior of the Bastión de San Diego presented a bleak view during the early stages of excavation. The Executive House is on the far right-hand corner of the picture, and to the left the concrete buttresses of the Pamantasan ng Lungsod ng Maynila cut through the Intramuros skyline to hold the earthquake-damaged building.*

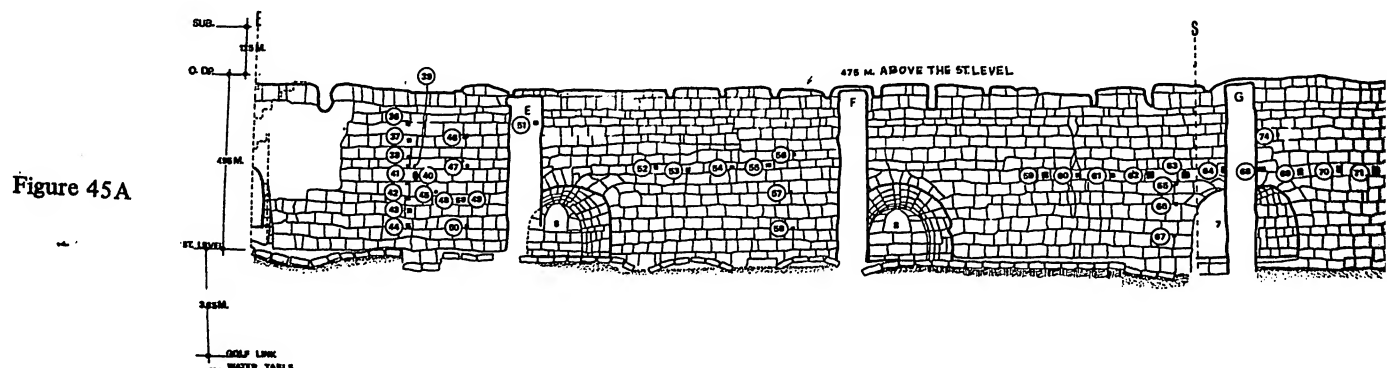
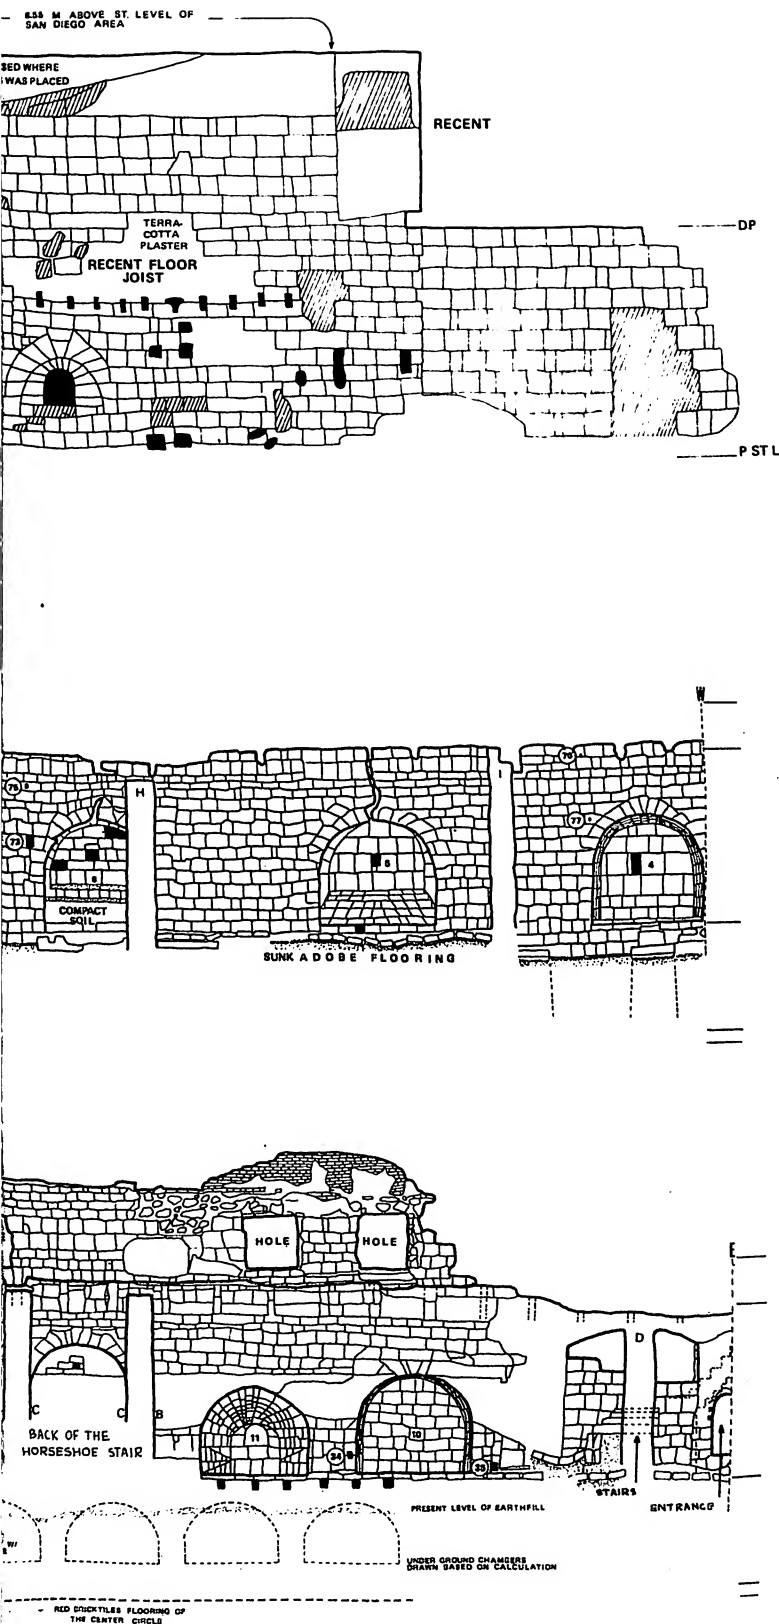
The surface of the structure is marred by cracks, particularly in chambers two, five, six and eight. The cracks widen near the keystone and extend upwards. The vaulted chambers have been sealed with adobe against the outside, but markings on the stone surface indicate that at one time, the recessed portion opened out to the surrounding marshland, the sea and the interior Plaza. Some had been barred with iron grates for security measure. Their construction suggests that they were originally intended as casemates. We note the sloping floor in some of the chambers, probably devised to push the cannon up its ramp, and the vaulted roof with

Figure 45, A and B. The documentation of the interior portion of the third circular structure showing the condition of the walls and casemates and the position of the buried chambers below the street level.

The archaeological excavation shows that the flooring outside the casemate is 3.45 meters above the water table. It is estimated that the underground arches that provide structural support to the tower would be at least 1.75 meters high, the average size of the casemates (Figure 45B). An adobe footing of at least another meter would be necessary to anchor its structure, adding up to almost the exact height of the lowered tower! Dasmariñas had shown himself an astute planner and builder and it is likely that it was in consideration of the foundation—how much weight it could have supported—which influenced his decision to limit the tower's height to 4.37 meters. The lessened height allowed the structure to settle evenly.

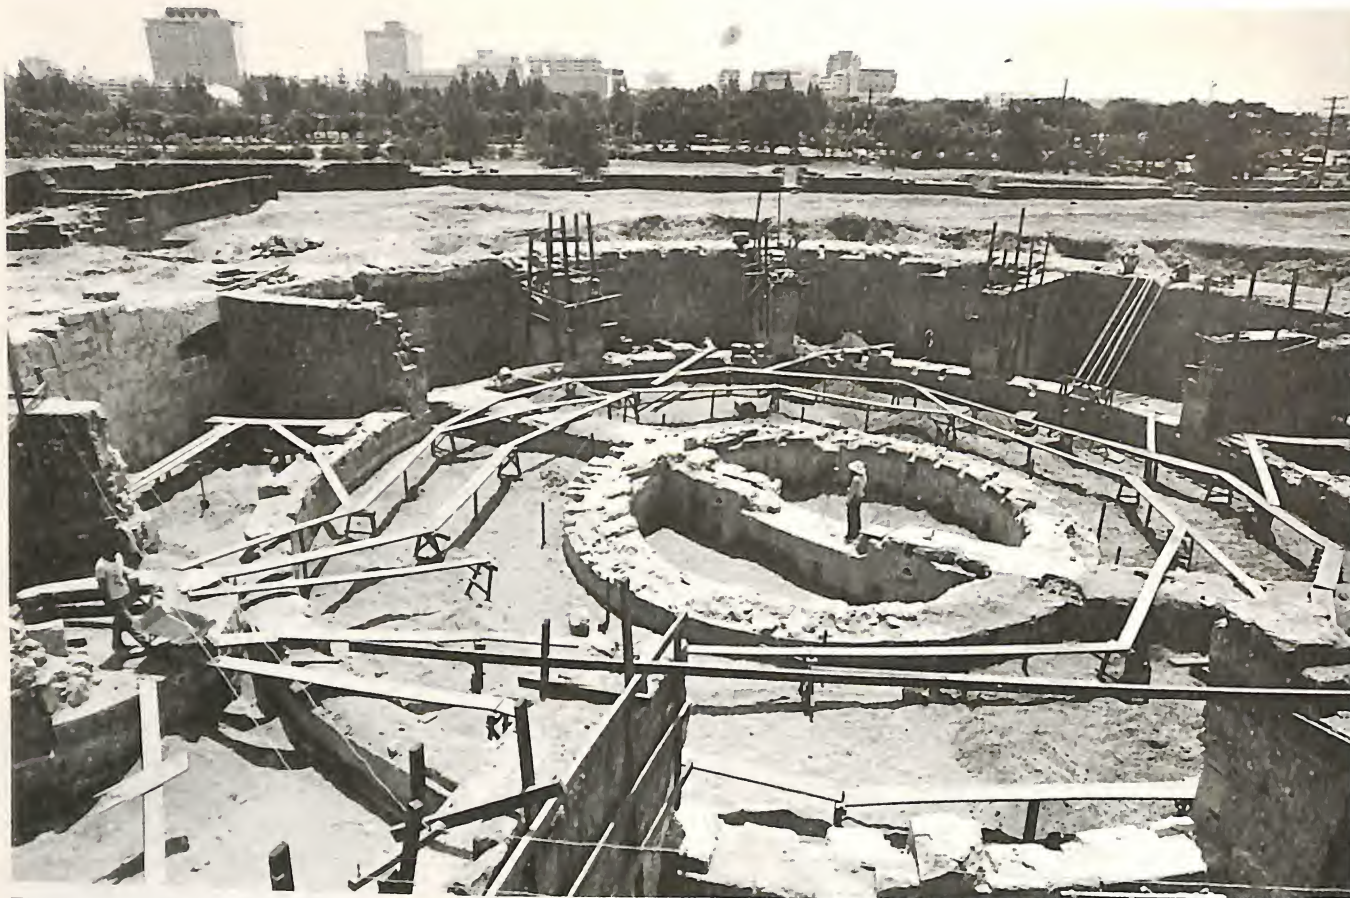
Figure 46. The two cylindrical structures in the early phase of the excavation. Some five meters deep of earthfill have already been removed.

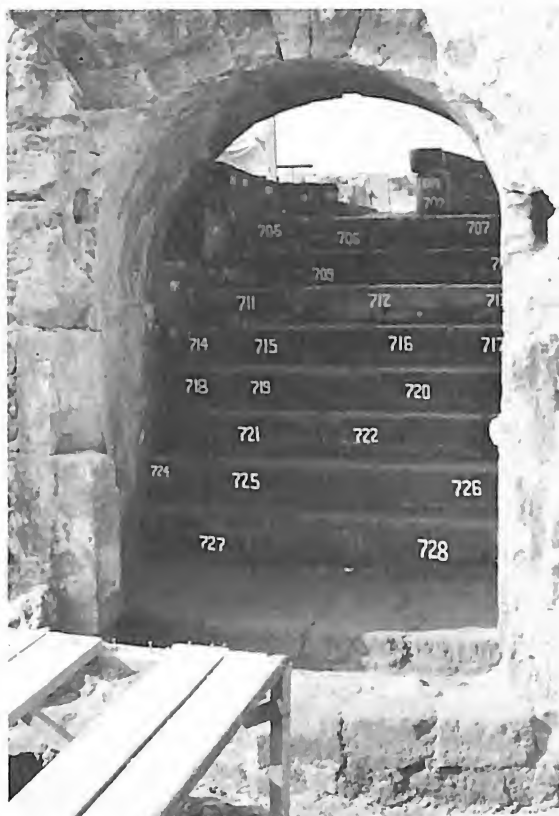
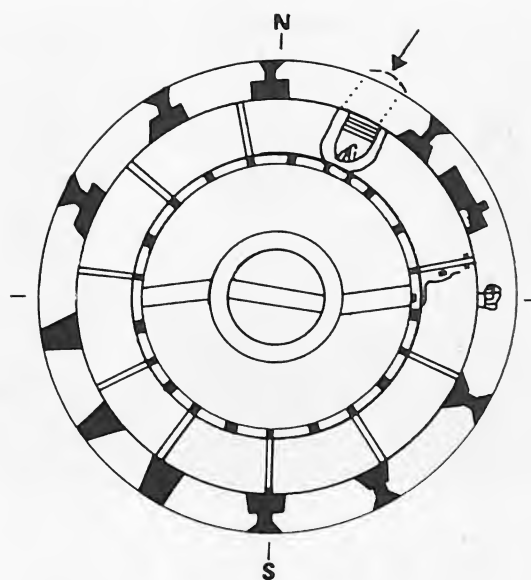
Figure 47. Marks on the door frame of the Bastión de San Diego indicate that one time it may have been barred with a swing-out metal or wooden door.

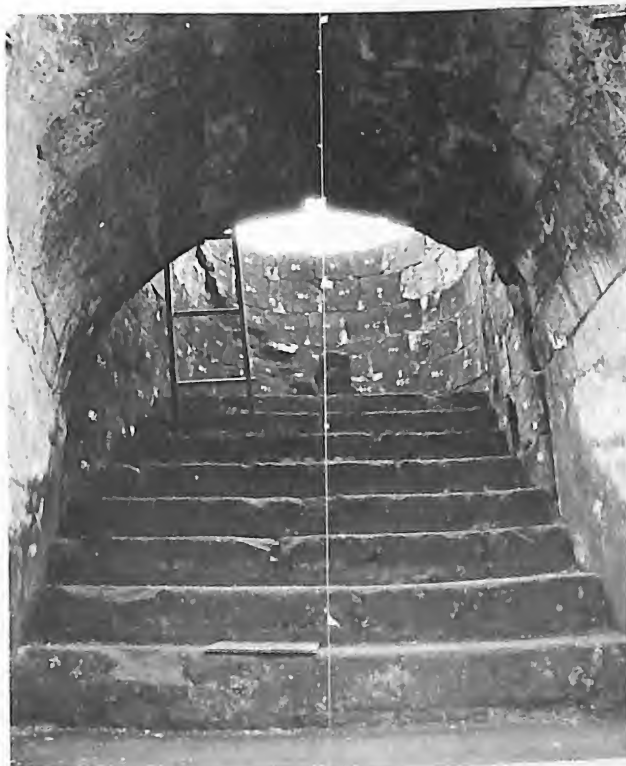
Figure 48. The main entrance of the Bastión de San Diego. On the wall of the stairwell, vestiges of the dismantled steps are visible on the stones.

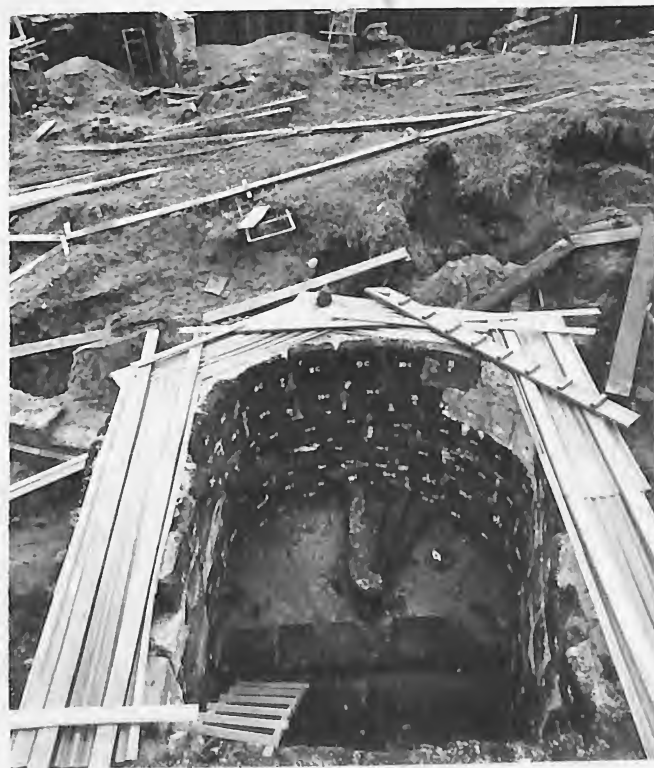
Figure 49. Top view of the horseshoe-shaped stairwell. On the landing are the remaining steps, spread out like a fan. Ridges left on the wall show the spiral ascent of the missing members of the stairs, which lead to the top of the bulwark.

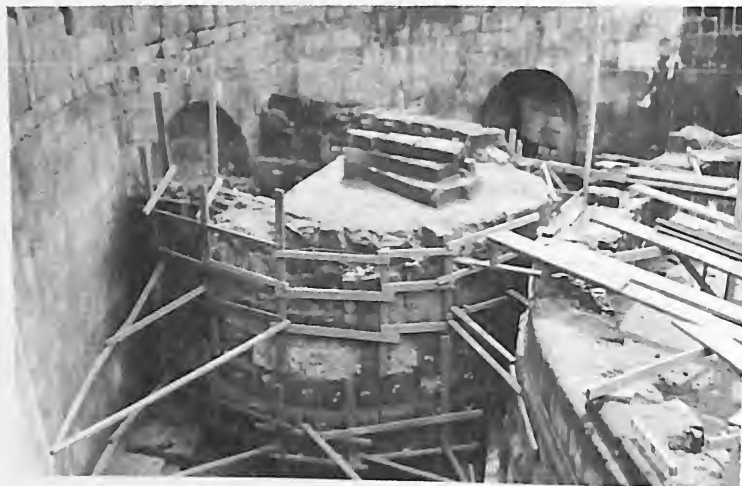
Figure 50. *Back view of the staircase on whose upper landing a spiral staircase was built.*

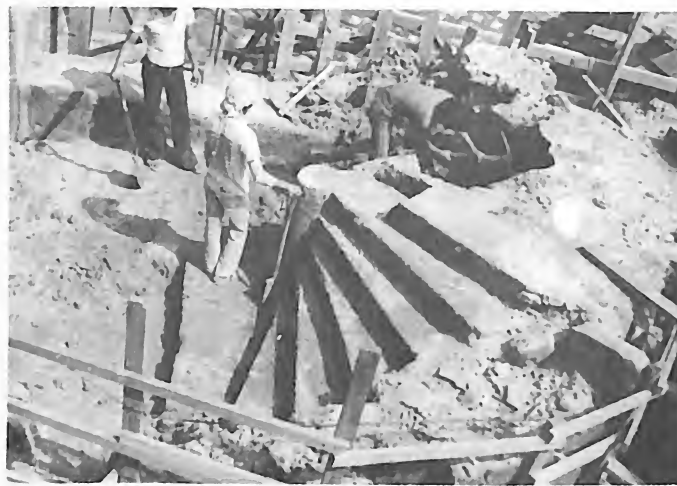
Figure 51. *The soil deposits surrounding the stairwell are being removed. The winding staircase is seemingly held together by a post, accenting its fanlike spread.*

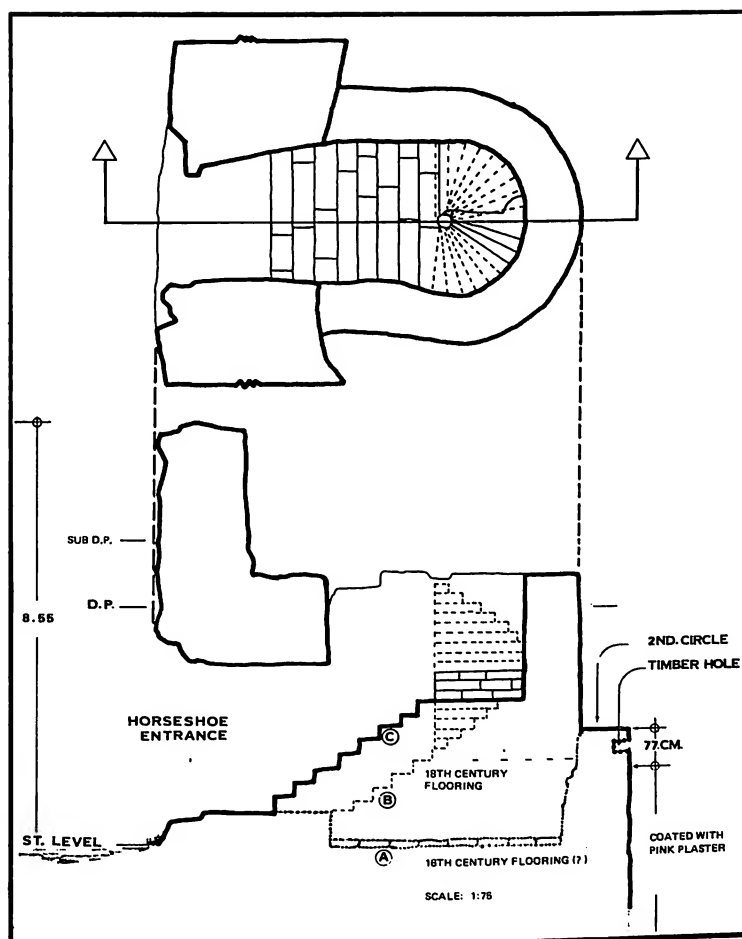
Figure 53. These sketches show the different elevations within and without the structure relative to the staircase. The present street level is almost on the same level as the flooring of an earlier period, possibly that of the 16th century. The present staircase appears to have been built on the older foundation.

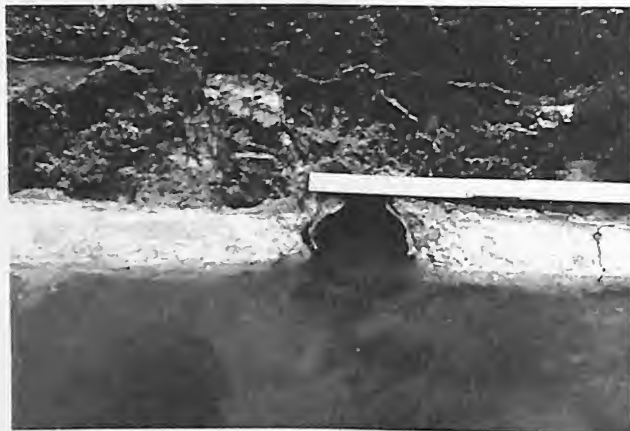
Figure 63. This water pipe with a diameter of seven centimeters is found on the flooring of the second circle on its dividing wall in the west quadrant.

structure (Figures 63-64). Two are on the east side, one positioned at 20 centimeters above the other; another is on the ground floor of the west wall. The brick flooring is 25 centimeters below the water table, hence ground water can be expected to fill up to that level, at least. At high tide, sea water also invades the cistern, a factor which actually contributes to its effectivity as a water reservoir. Since saline water is naturally heavier than fresh water, it settles below, while perched fresh water stays atop the salt water, thus rising high. But this clearly was not enough to fill the huge structures. The apparent source was rainfall.

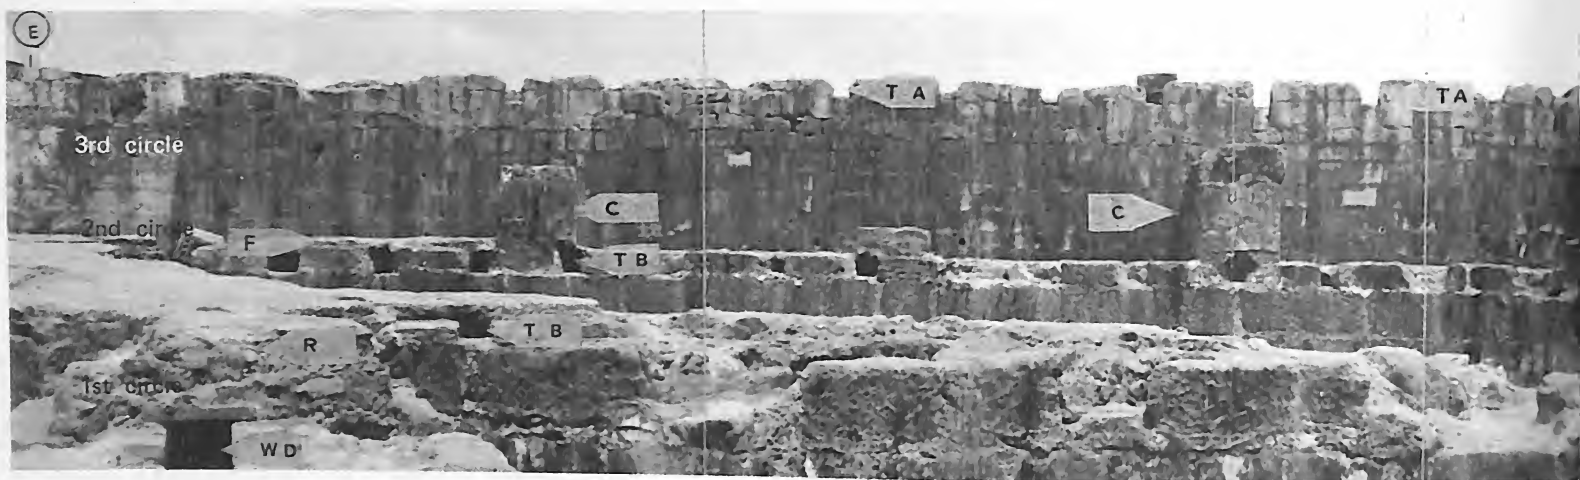
Figure 68. The top section of the outer bulwark and the cistern showing the timberholes, pillars and dividing wall. Roofing structure of the third circle rests on a post implanted on the pillar or column.
